SIL 413.00

NOVEMBER 13, 2008

SUBJECT: Hoist Cylinder Spherical Ball Lubrication

MODELS: L-950, L-1150, L-1350 Loaders

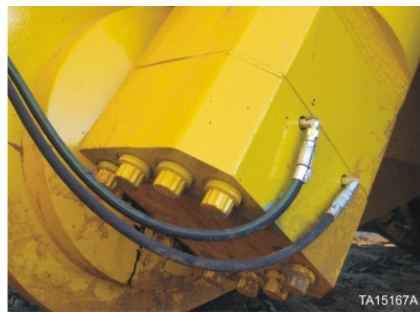
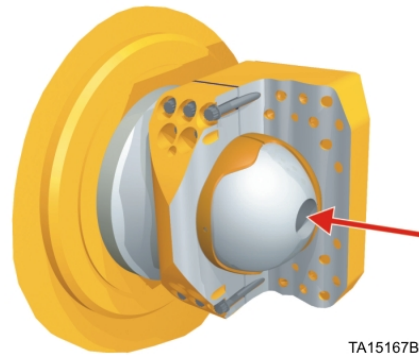
The hoist cylinder balls on the 950, 1150 and 1350 are greased through the ball cap/socket.

External greasing of the ball

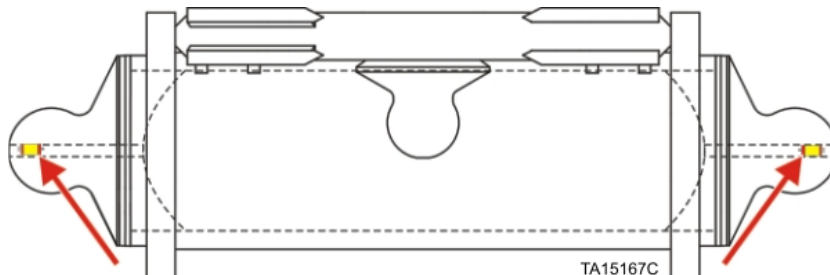
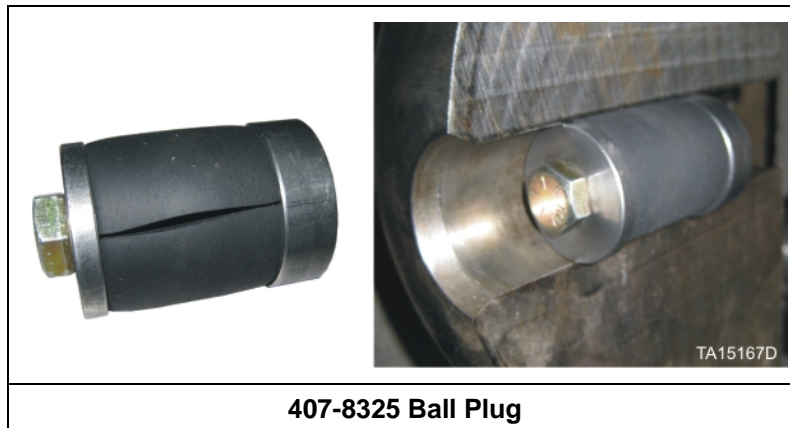
407-8325 Ball Plug locations

When the ball is greased through the cap/socket there is a plug placed in the center of the ball to force the grease to go through the brass liners and prevent grease from entering the tube.

This grease plug must not move or grease will flow to the inside of the ball and tube structure – and have limited or no grease on the brass liners. This will lead to rapid wear of the brass liners and the seal groove of the socket will cut into the neck of the ball. The grooving will cause high stresses in the neck and can cause the ball to break off.

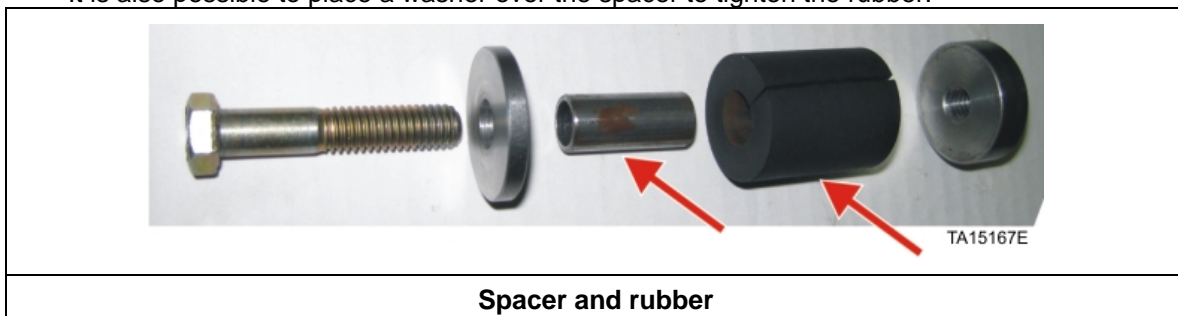
- The OD of the spacer washer and nut had to be ground down to fit into the undersize hole.
- It is also possible that the hole in the ball may have been modified by grinding so that the 407-8325 plug will fit

- The rubber composition has changed and it is not as flexible as it once was and does not fully expand.
- It is possible to shorten the spacer so that the rubber will expand more fully
- It is also possible to place a washer over the spacer to tighten the rubber.

Bottom line: The plug must be tight in the bore and must not move.
